The Timber and Construction of Dragon Hall

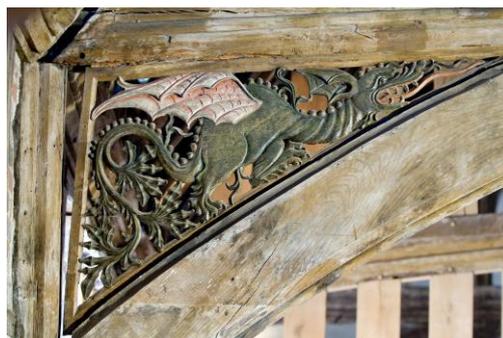
The third source of timber was slow-grown radial planks, imported from the Eastern Baltic. The remaining dragon in a spandrel in the Great Hall was carved on these fine boards.

Dragon carving in spandrel

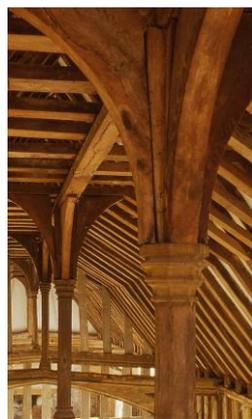
The floor joists and spine or central beams and their joints were prefabricated and assembled on the ground to check everything fitted before being reassembled in their final position. The roof timbers were made in sets and then a set was used randomly. In three of the ground floor rooms you can see the carpenters' marks as Roman numerals used to identify each joint when the building was erected. The roof is of a crown post type with four braces to the purlin and collar above. "Crown" refers to the shape of the moulding at the top of the post.

The crown post roof

The joints for the cross or tie beams, crown posts and arch braces are mortice and tenon with oak pegs to hold them together. One could say that with no use of screws, nails or glue the hall is held together by these pegs.

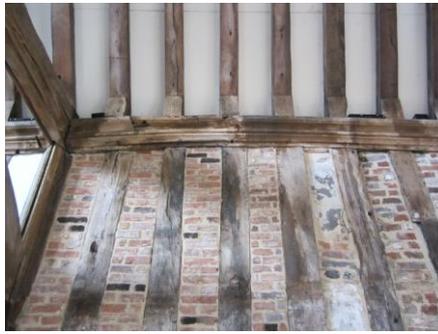
The wall posts or studs were placed much closer together than is structurally necessary and than in most medieval buildings, suggesting that Robert Toppes wanted to show off the cost of his trading hall. Likewise the decorative mouldings on the facing edges of the wall posts, of a type more commonly found in wealthy domestic buildings, were designed to impress his customers. In addition, brick infilling between the studs was used rather than the cheaper wattle and daub, although it is possible that the bricks were inserted later when the hall was converted into living spaces.

Studs with brick infill

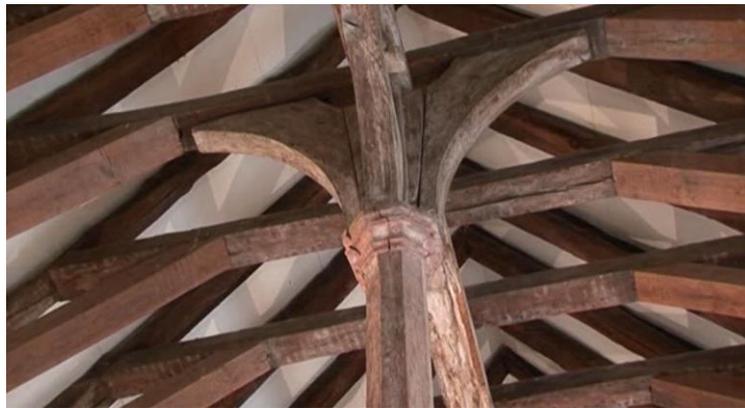
Close up of crown post
